Manhole Inspection Summary

Manhole # S39U__039MH

Insp Date: **2/19/09 10:04 AM**

Location Address: **rear 1613 jackson st**

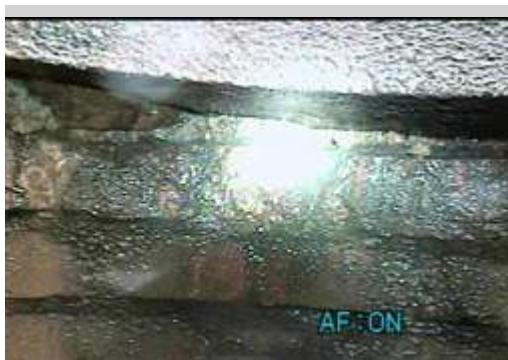
Defect 1

Condition: ☐ Sound ☐ Cracked ☐ Root Intrusion ☒ **Loose Brick** ☒ **Deteriorated**

Infiltration: ☐ None ☐ Joint ☐ Cracks ☐ Mortar ☐ Roots ☒ **Wall**

chimney loose bricks, infiltration

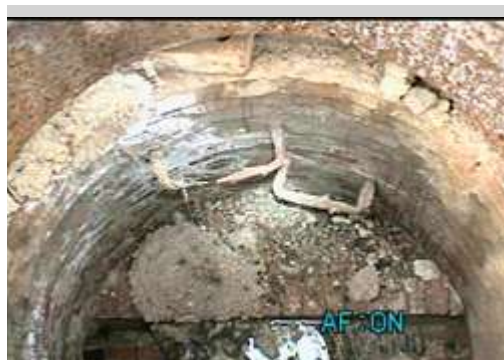
Defect 4

Steps Count: **2** Missing: **1** ☒ **Corroded**

chimney deteriorated, corr steps

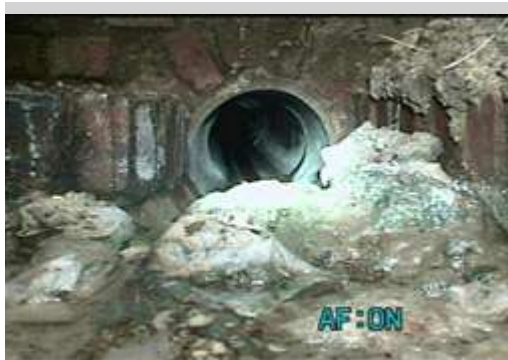
Defect 3

Condition: ☐ Sound ☐ Cracked ☐ Root Intrusion ☐ Deteriorated ☐ Leaks ☒ **Debris**

channel debris

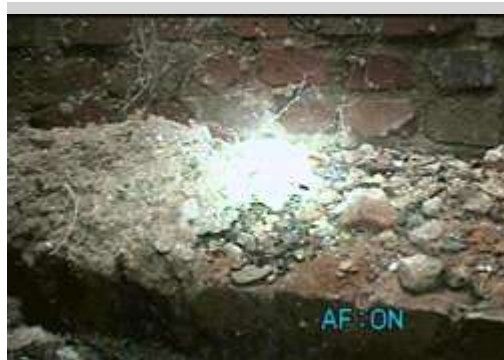
Defect 2

Condition: ☐ Sound ☐ Cracked ☐ Root Intrusion ☐ Deteriorated ☐ Leaks ☒ **Debris**

bench debris

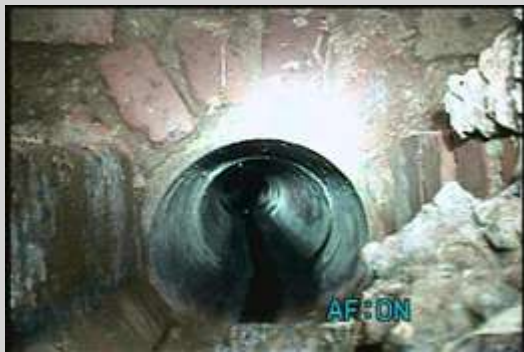
12 O'Clock Outflow

8 in. Circular Gravity Sewer
Pipe Out @ 12 O'Clock

Pipe Material: **Clay** ☐ Pipe Lined

Invert Depth: **5.62** (ft.) Flow Characteristics: **Fast**

Infiltration: **None** Pipe Seal Cond: **Unknown**

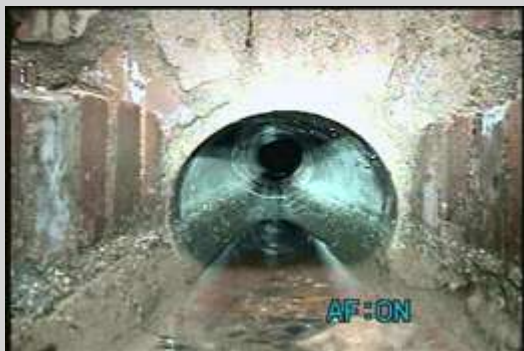
6 O'Clock Inflow

8 in. Circular Gravity Sewer
Pipe In @ 6 O'Clock

Pipe Material: **Clay** ☐ Pipe Lined

Invert Depth: **5.38** (ft.) Flow Characteristics: **Slow**

Infiltration: **None** Pipe Seal Cond: **Unknown**

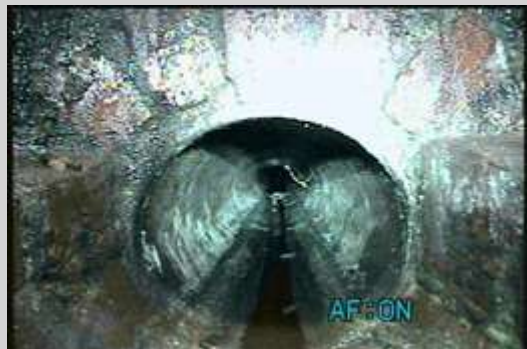
9 O'Clock Inflow

8 in. Circular Gravity Sewer
Pipe In @ 9 O'Clock

Pipe Material: **Clay** ☐ Pipe Lined

Invert Depth: **5.29** (ft.) Flow Characteristics: **Slow**

Infiltration: **None** Pipe Seal Cond: **Unknown**
